# United States Antarctic Program

## Palmer Pier Above Waterline Structural Survey RPSC & NSF

2/10/2009

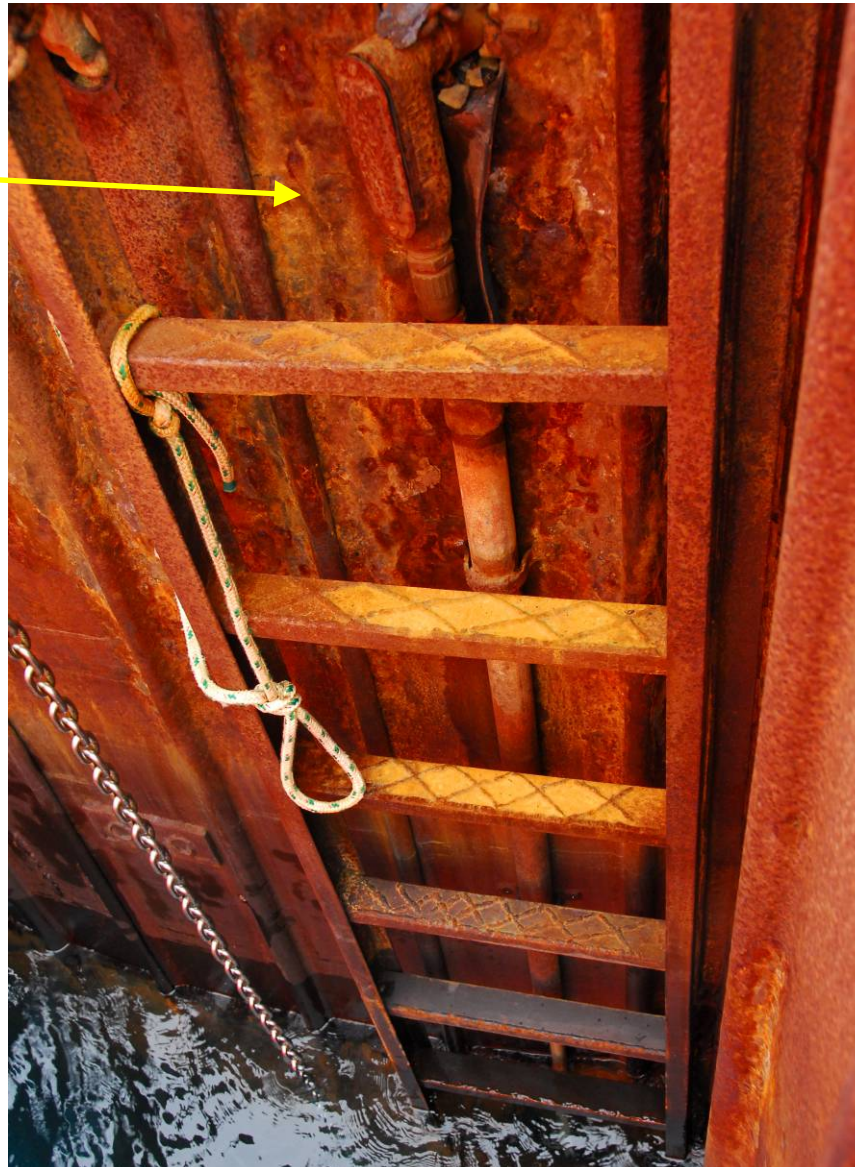
# More Corrosion

0.1" thick in places

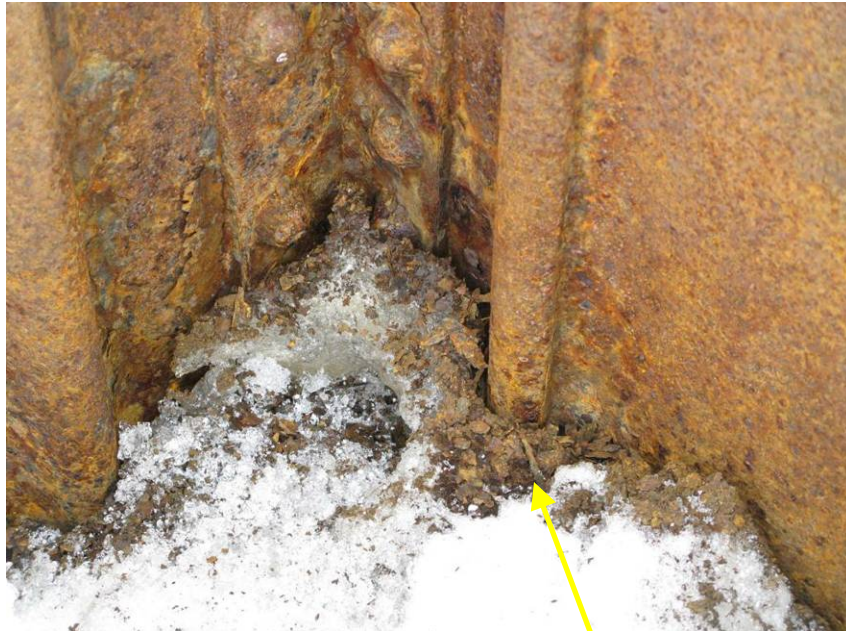
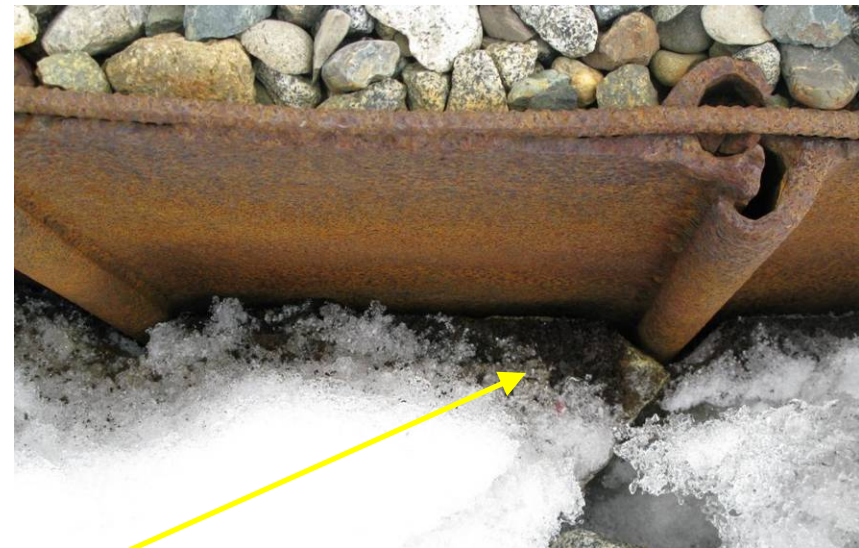
# Flaking

Flaking of Sheet Piles. (Enough flaking to show on top of seasonal snows)

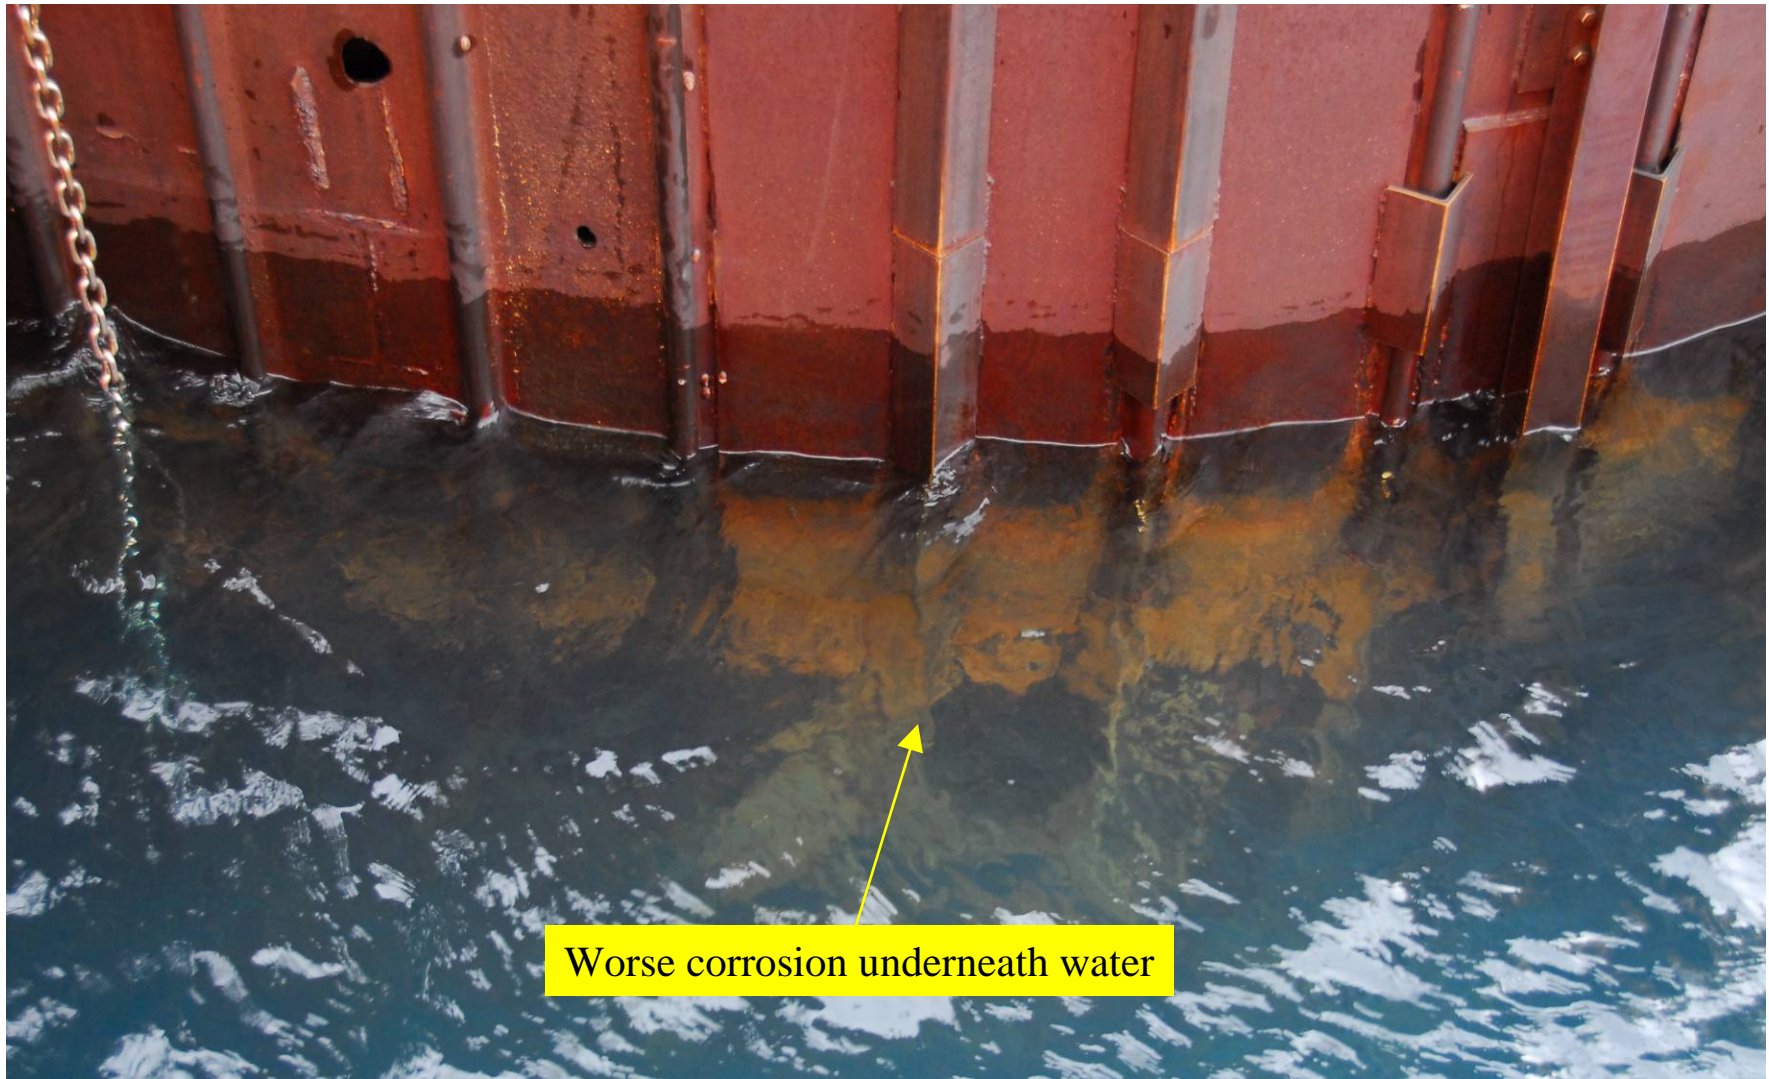
# Underwater Corrosion

Worse corrosion underneath water

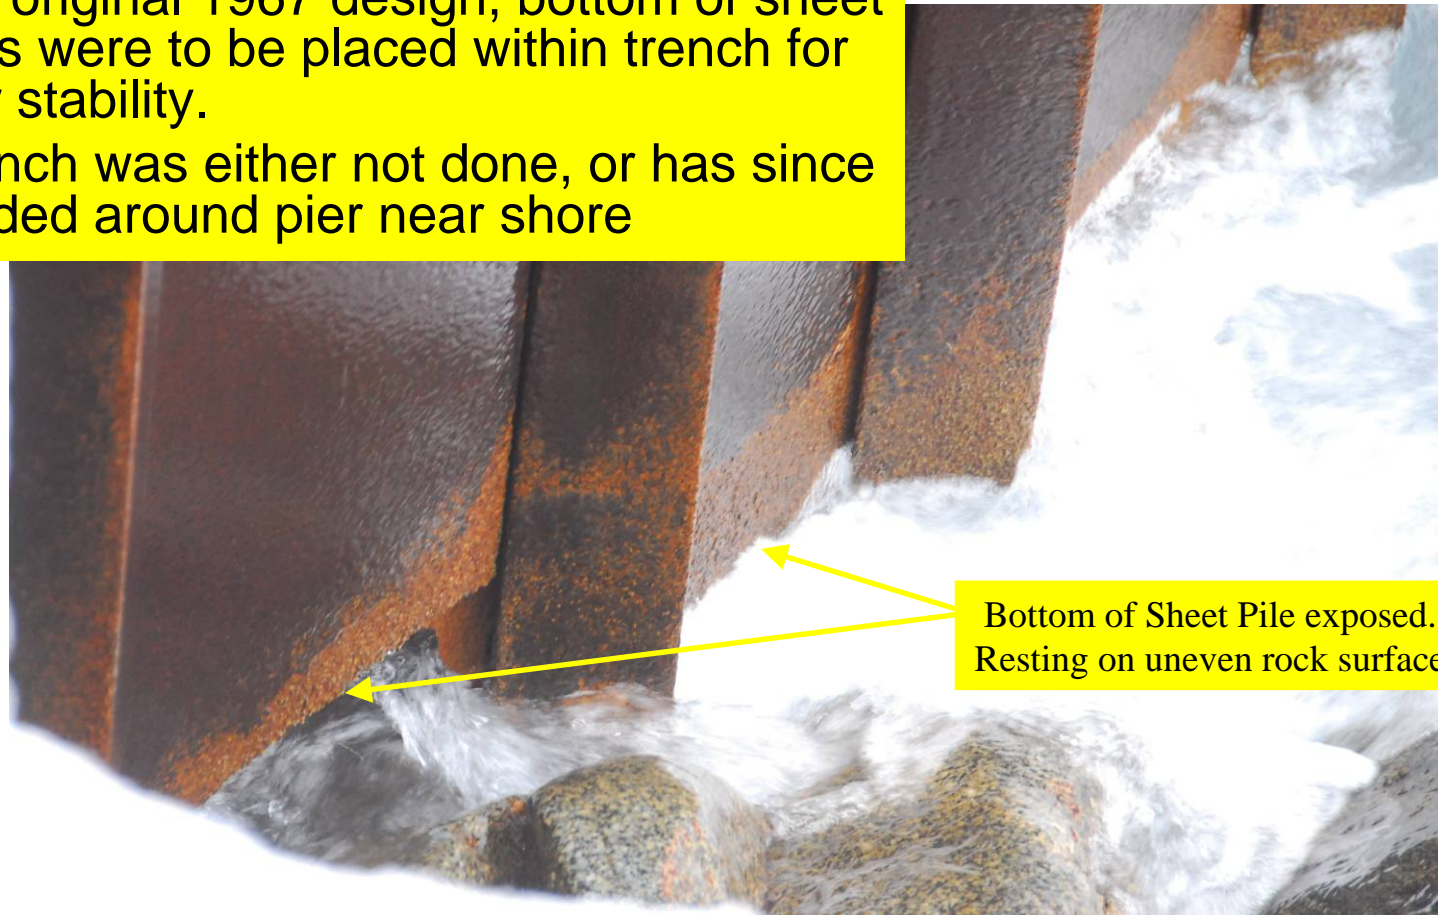
## Pier Foundation

- Per original 1967 design, bottom of sheet piles were to be placed within trench for pier stability.
- Trench was either not done, or has since eroded around pier near shore

Bottom of Sheet Pile exposed.  
Resting on uneven rock surface

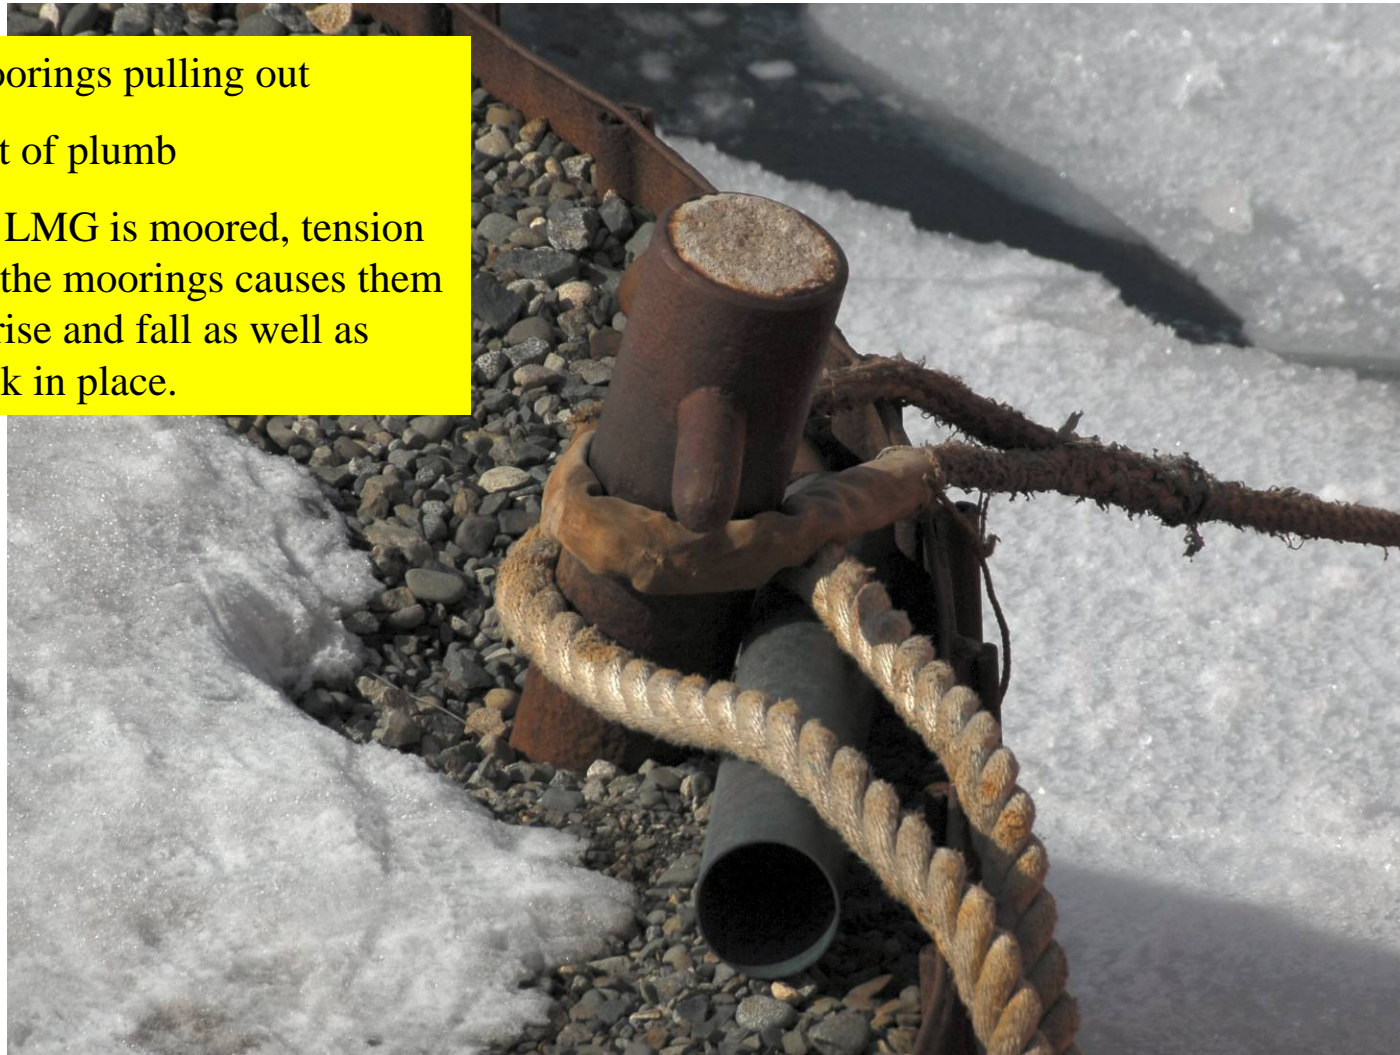
# Unsecure Moorings

1. Moorings pulling out
2. Out of plumb
3. As LMG is moored, tension on the moorings causes them to rise and fall as well as rock in place.

- Further measurements should be taken with new probe during next year's inspection
- Additional areas of corrosion need to be repaired
- Mooring procedure has been changed to reduce pressure against pier
- Use pier for two years with annual inspection program

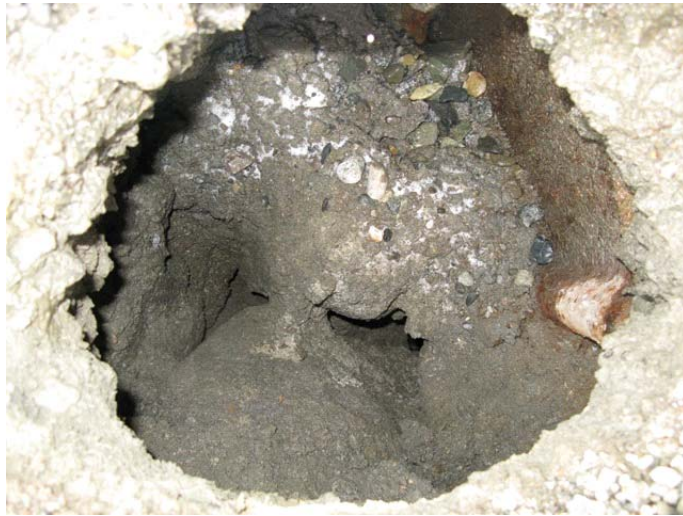
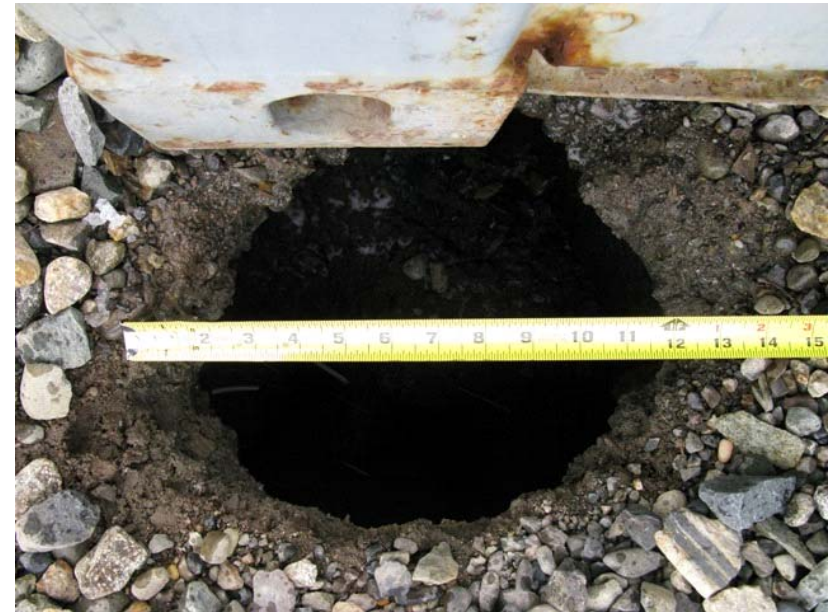
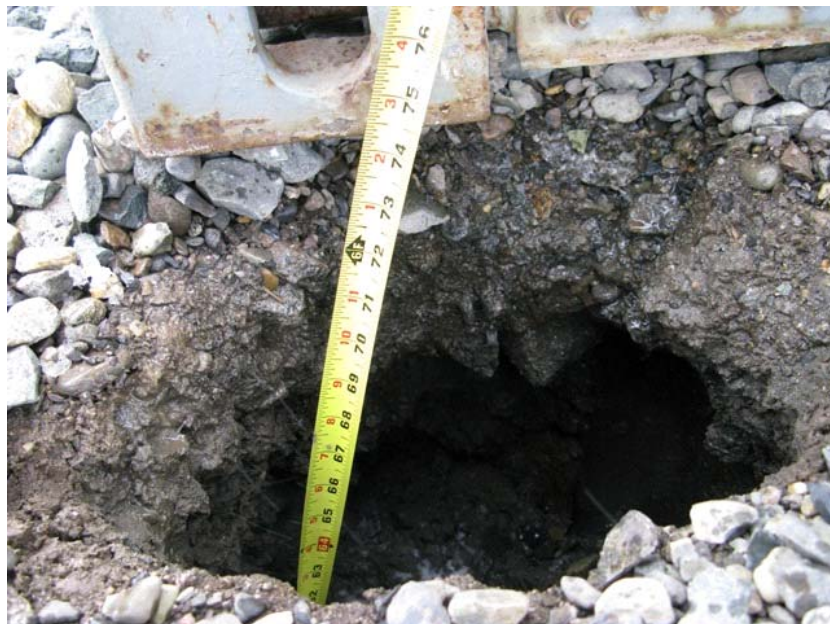
# Sink Hole

Largest Sink Hole to date appeared as LMG left Palmer 10/24/2008

- 14” in diameter with undercut edges
- 6 feet deep

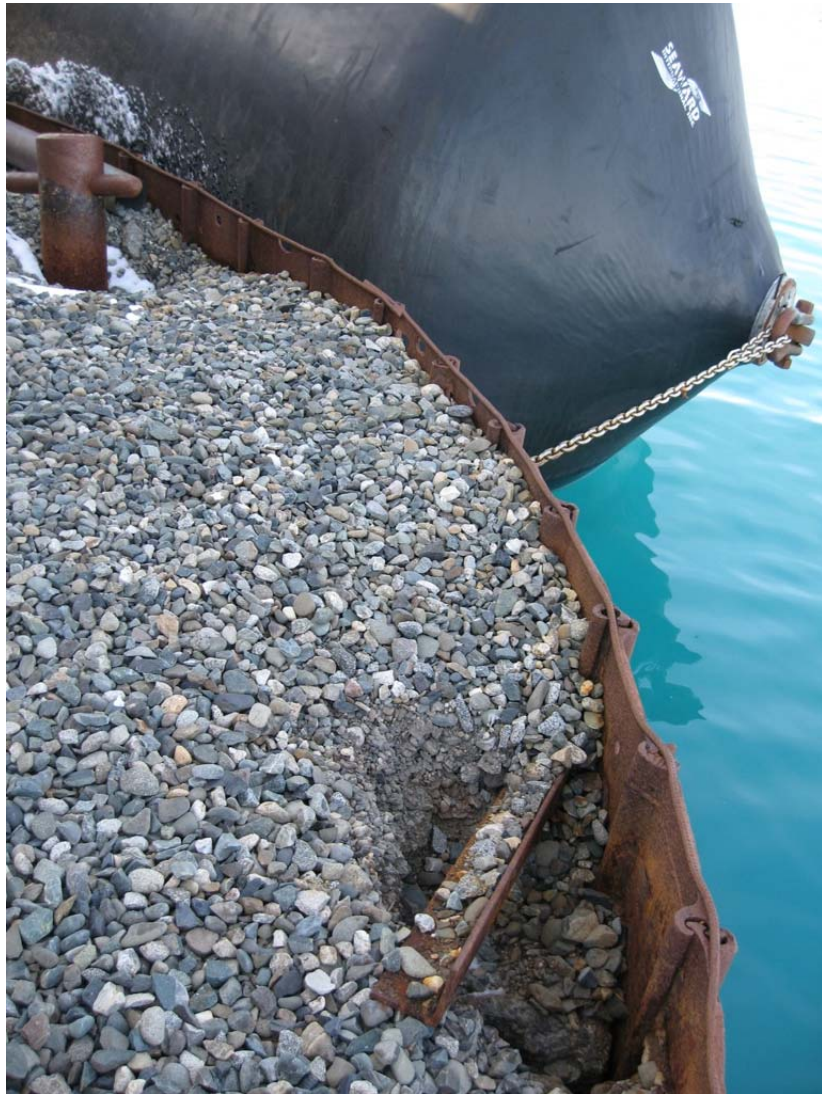
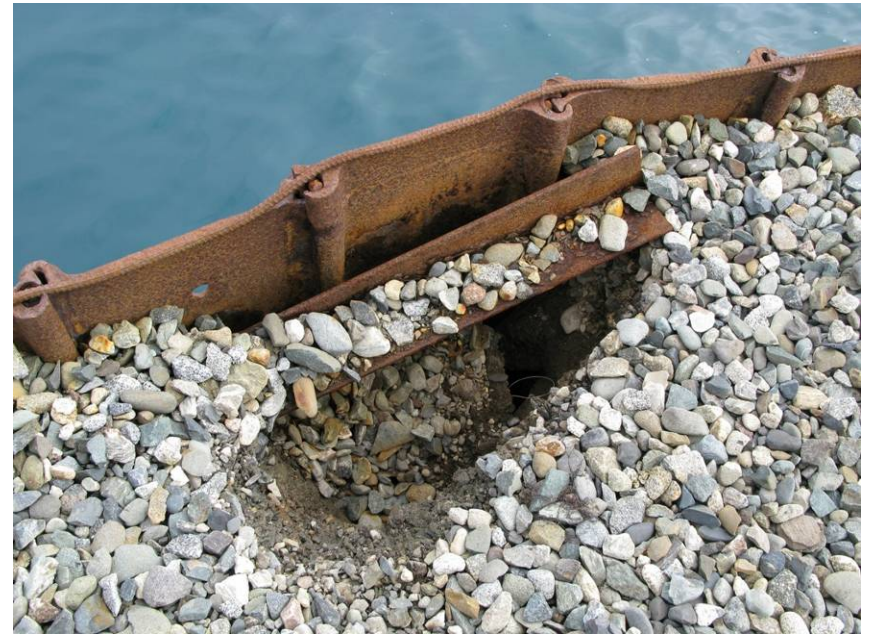
# Sink Holes

New Sink Hole  
11/4/2008

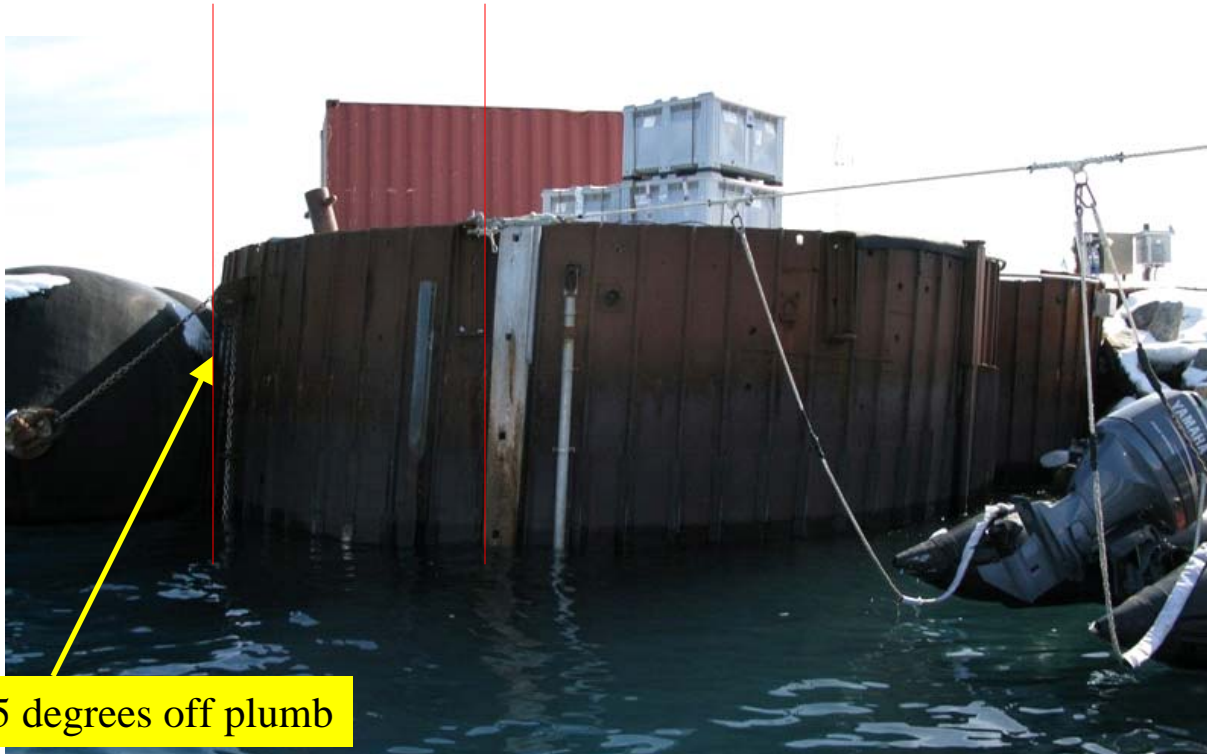
# Pier Lean

Pier Wall 5 degrees off plumb

- Many holes due to corrosion present in piles throughout
  - Cell II has seen the most corrosion
- Walls along mooring edge of pier 5 degrees out of plumb
  - Tilted toward Station, most likely as a result of the ship's pressure on the pier
- Large sink holes forming over Cell II and Section A of pier
- Large holes in Pier above and below water ~10 inches
  - Wave action may contribute to loss of fill behind these holes creating voids
- Areas of significant corrosion resulting in uneven surface (unable to measure thickness with ultrasonic sensor)

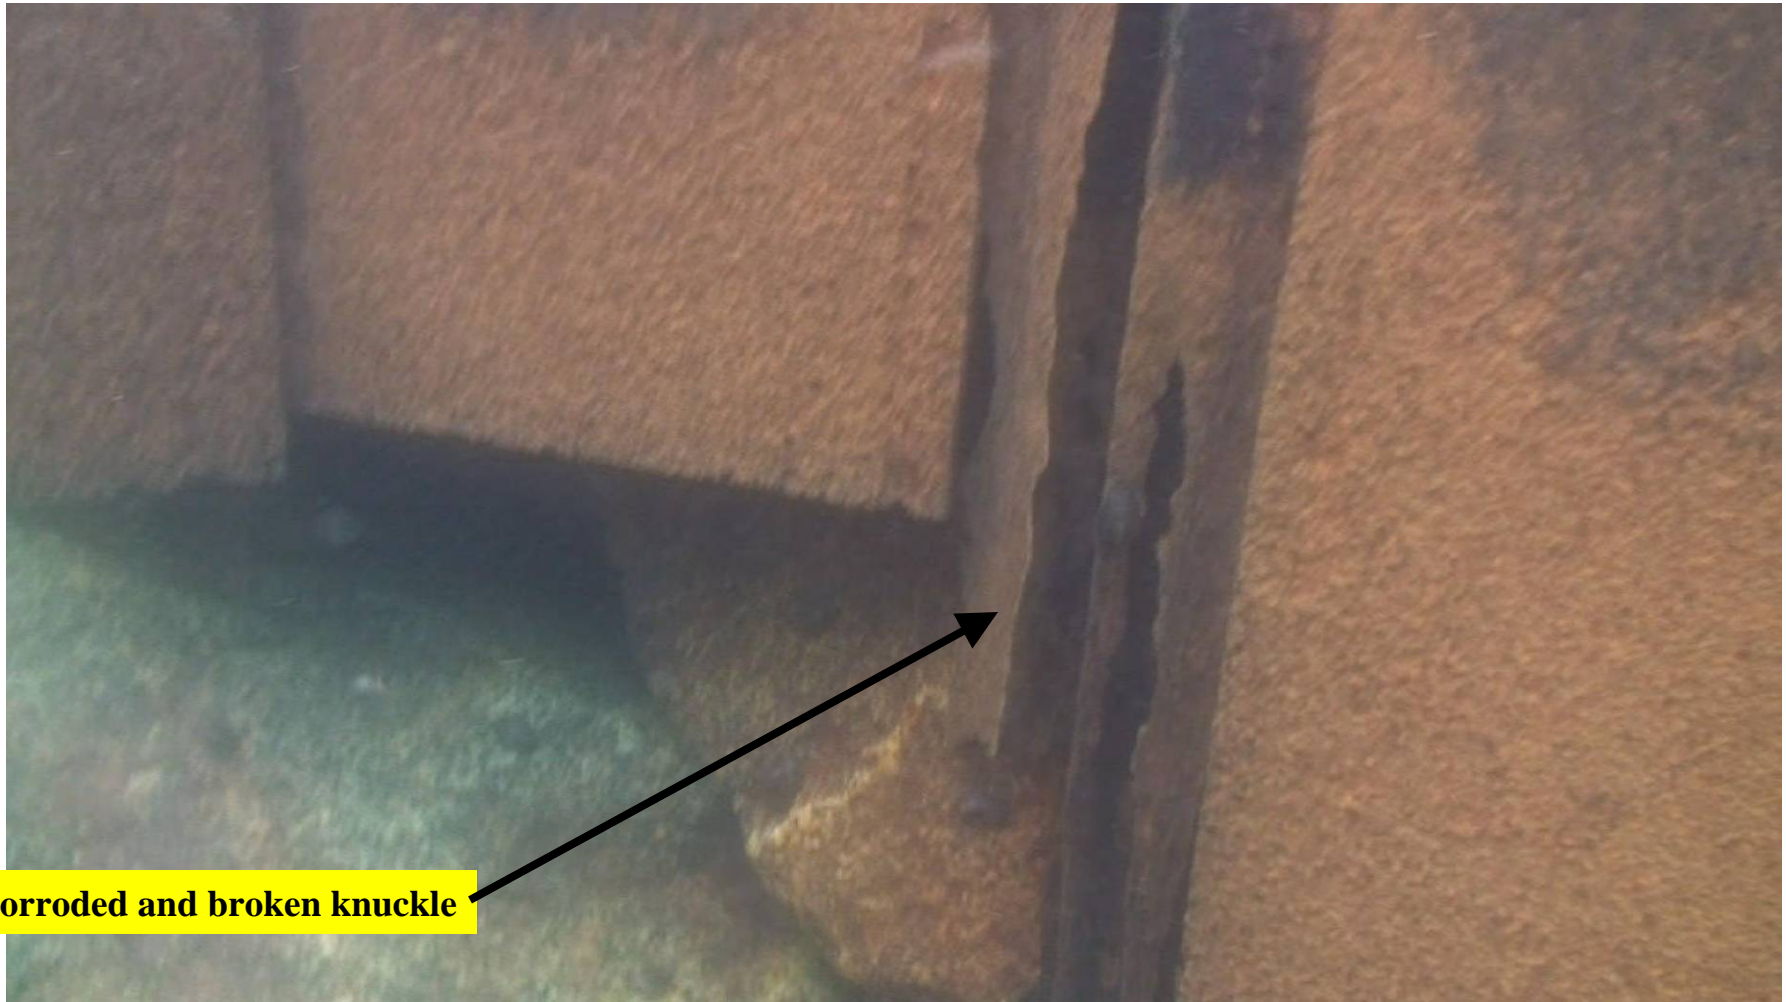
# Pier Bottom

Corroded and broken knuckle

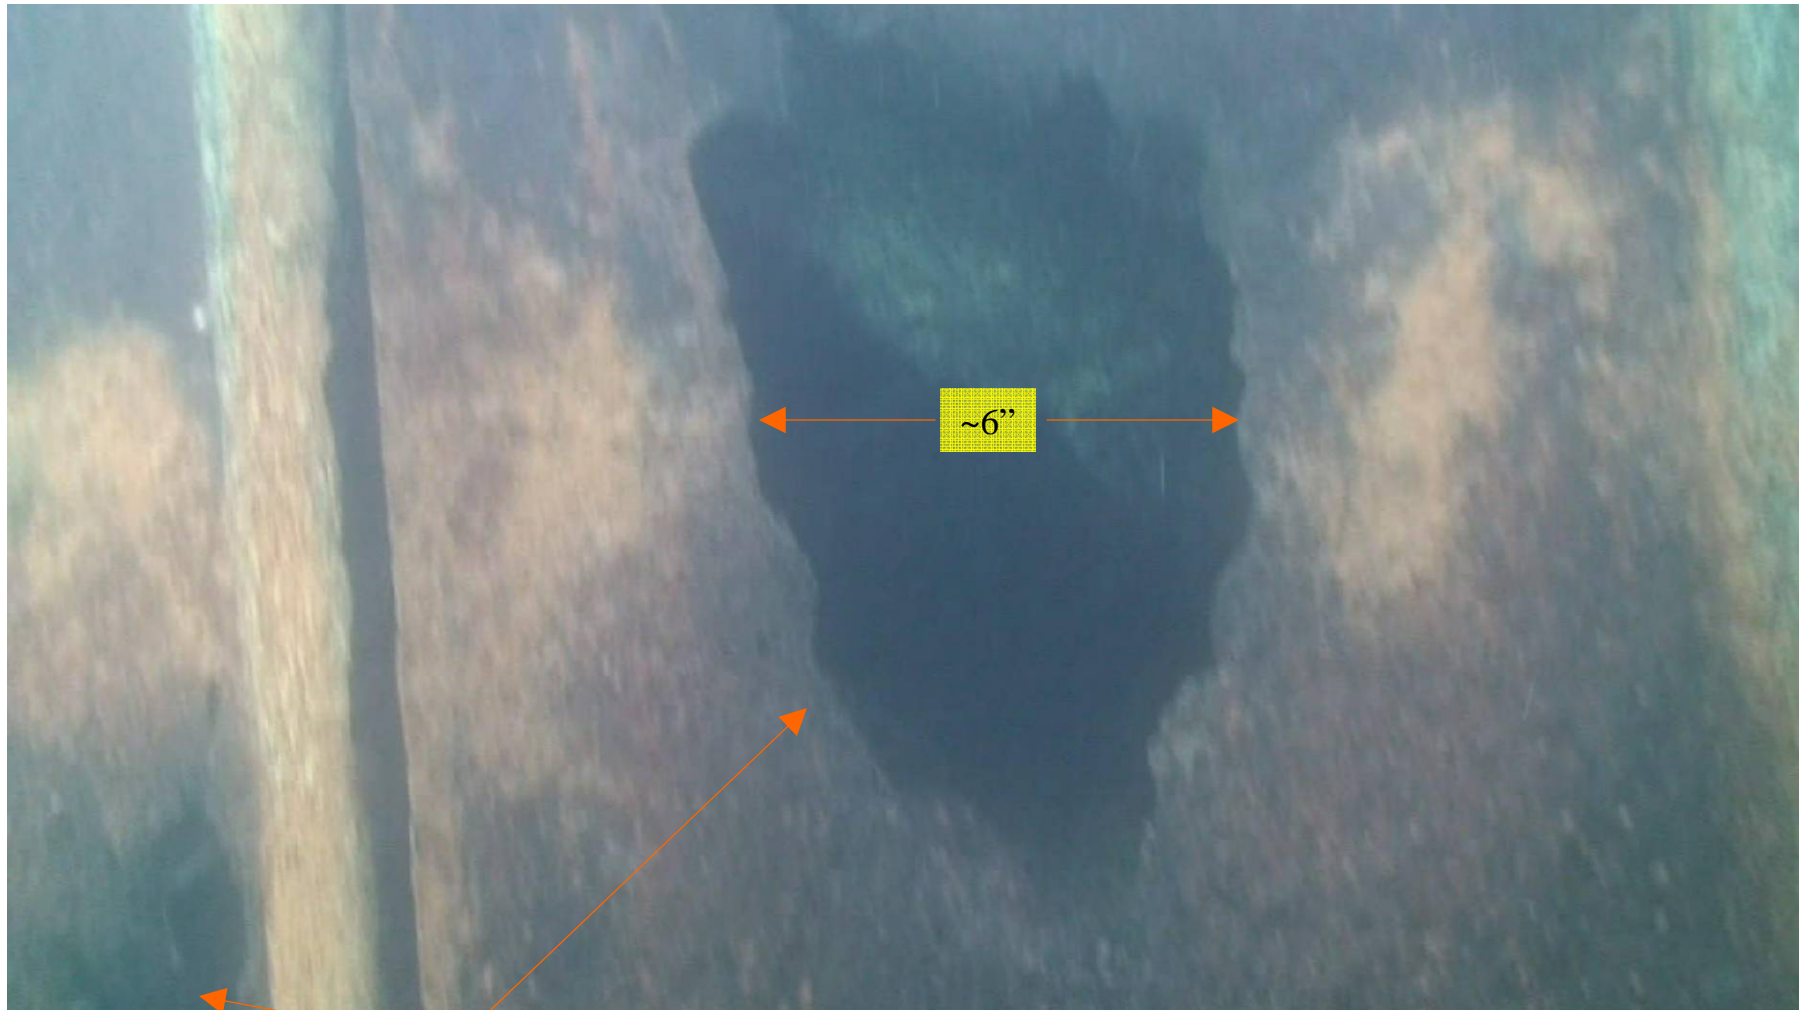
# Hole in Pier

Holes in Pier

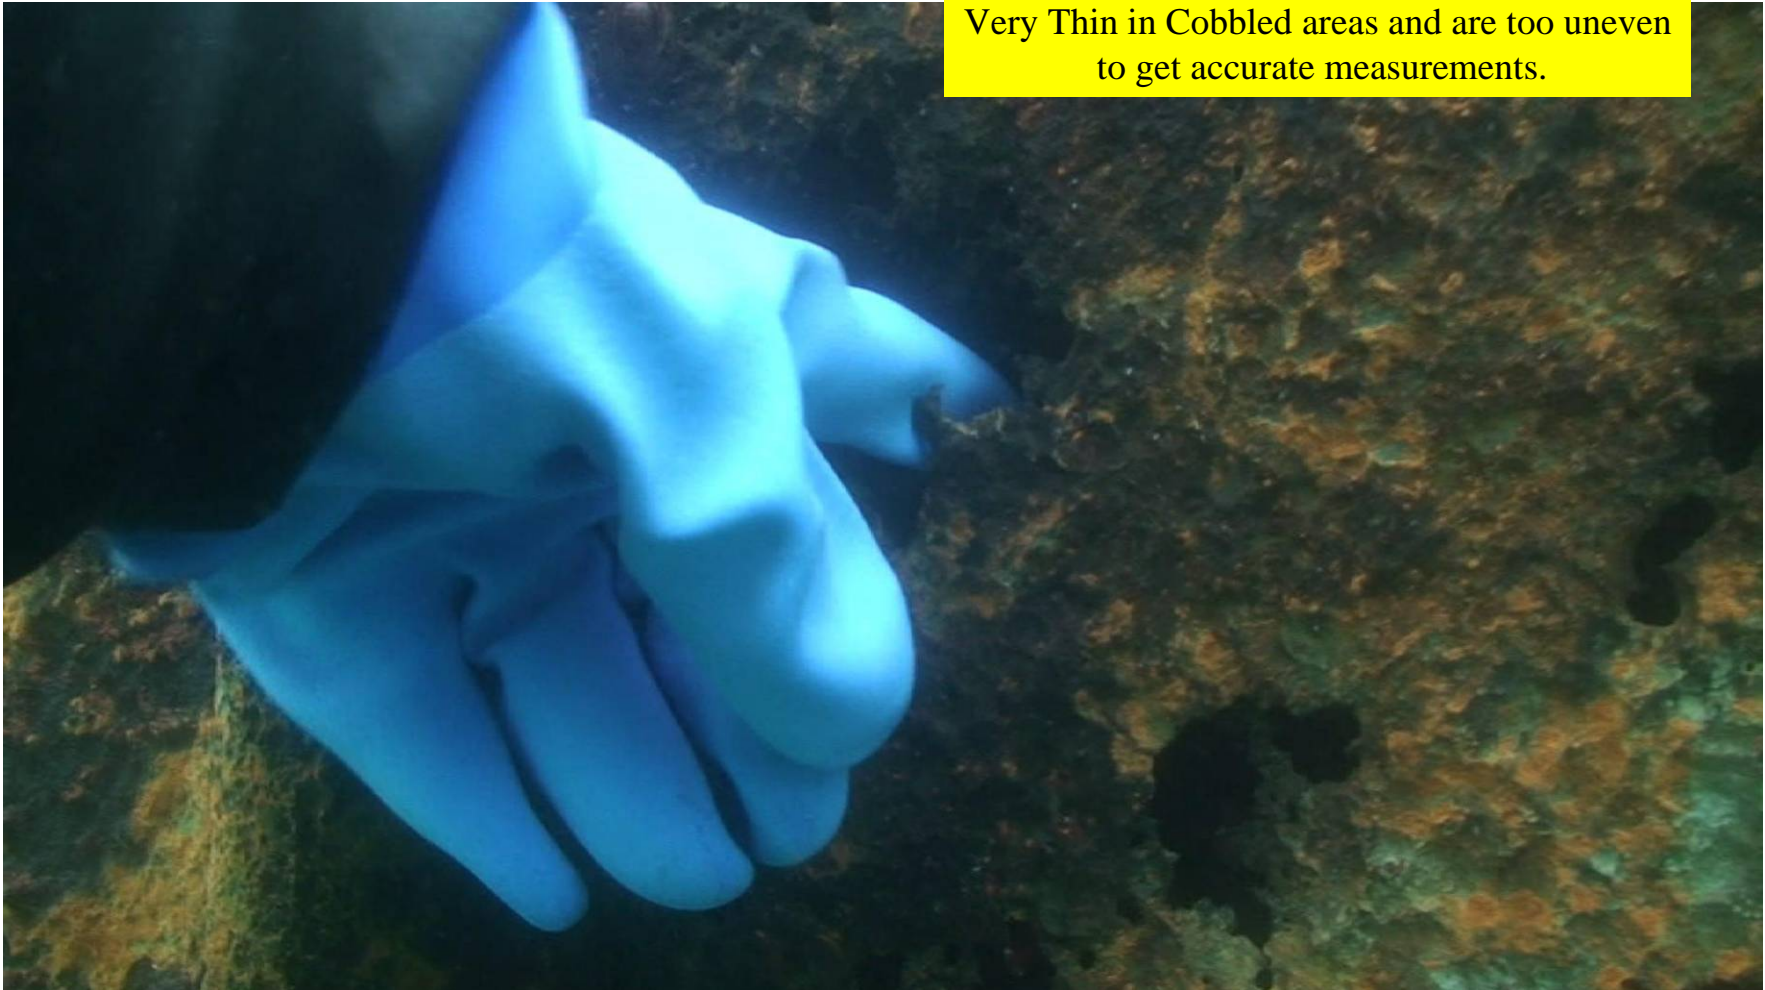
## Cobbled Area

Very Thin in Cobbled areas and are too uneven to get accurate measurements.

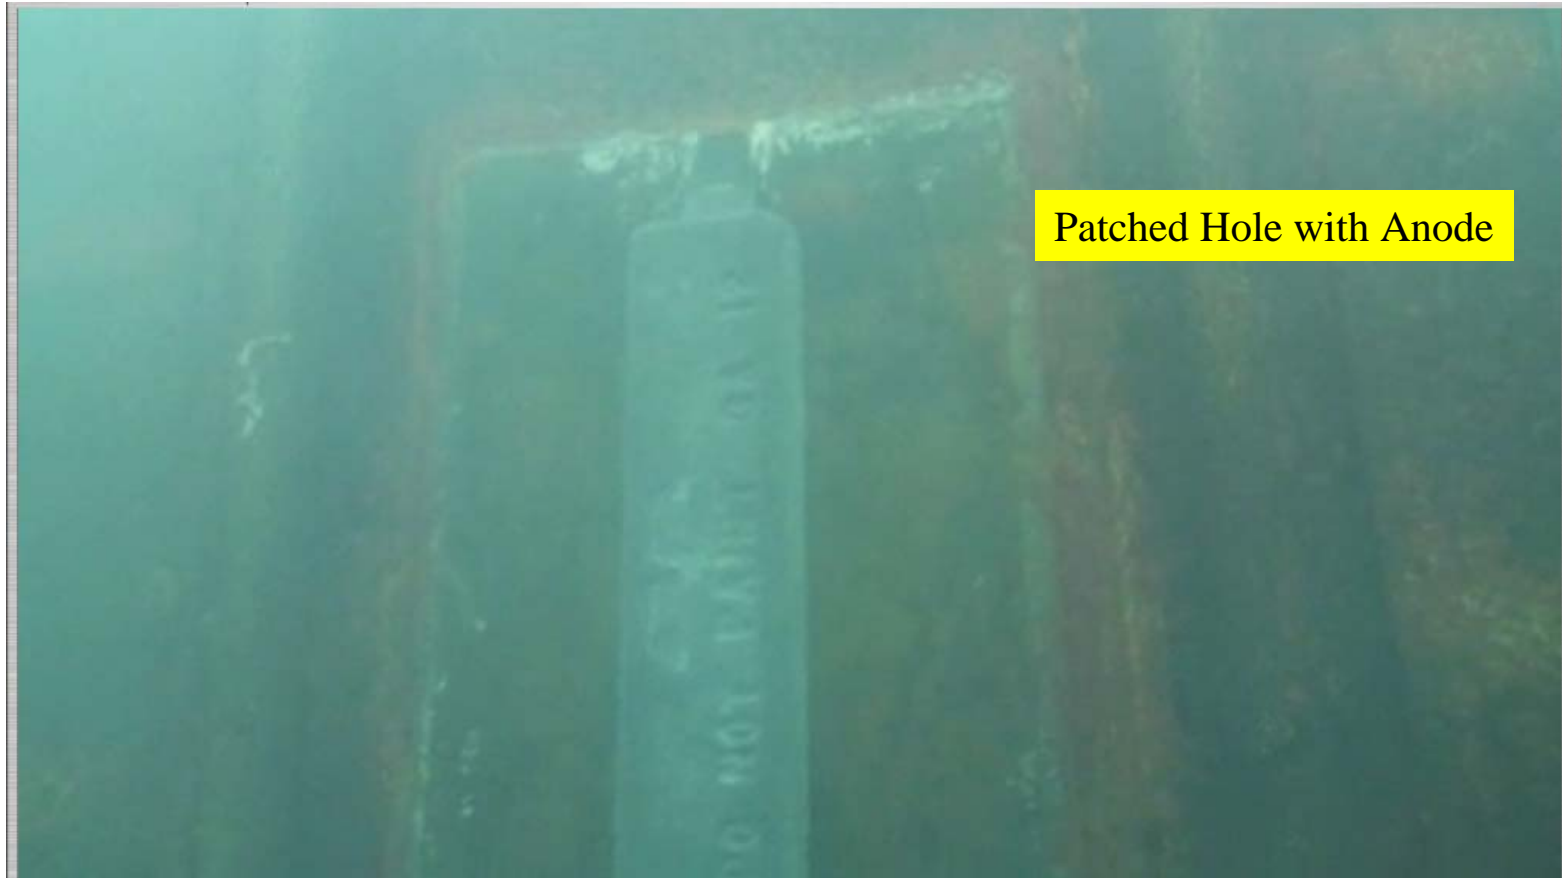
# Hole Repair

Patched Hole with Anode

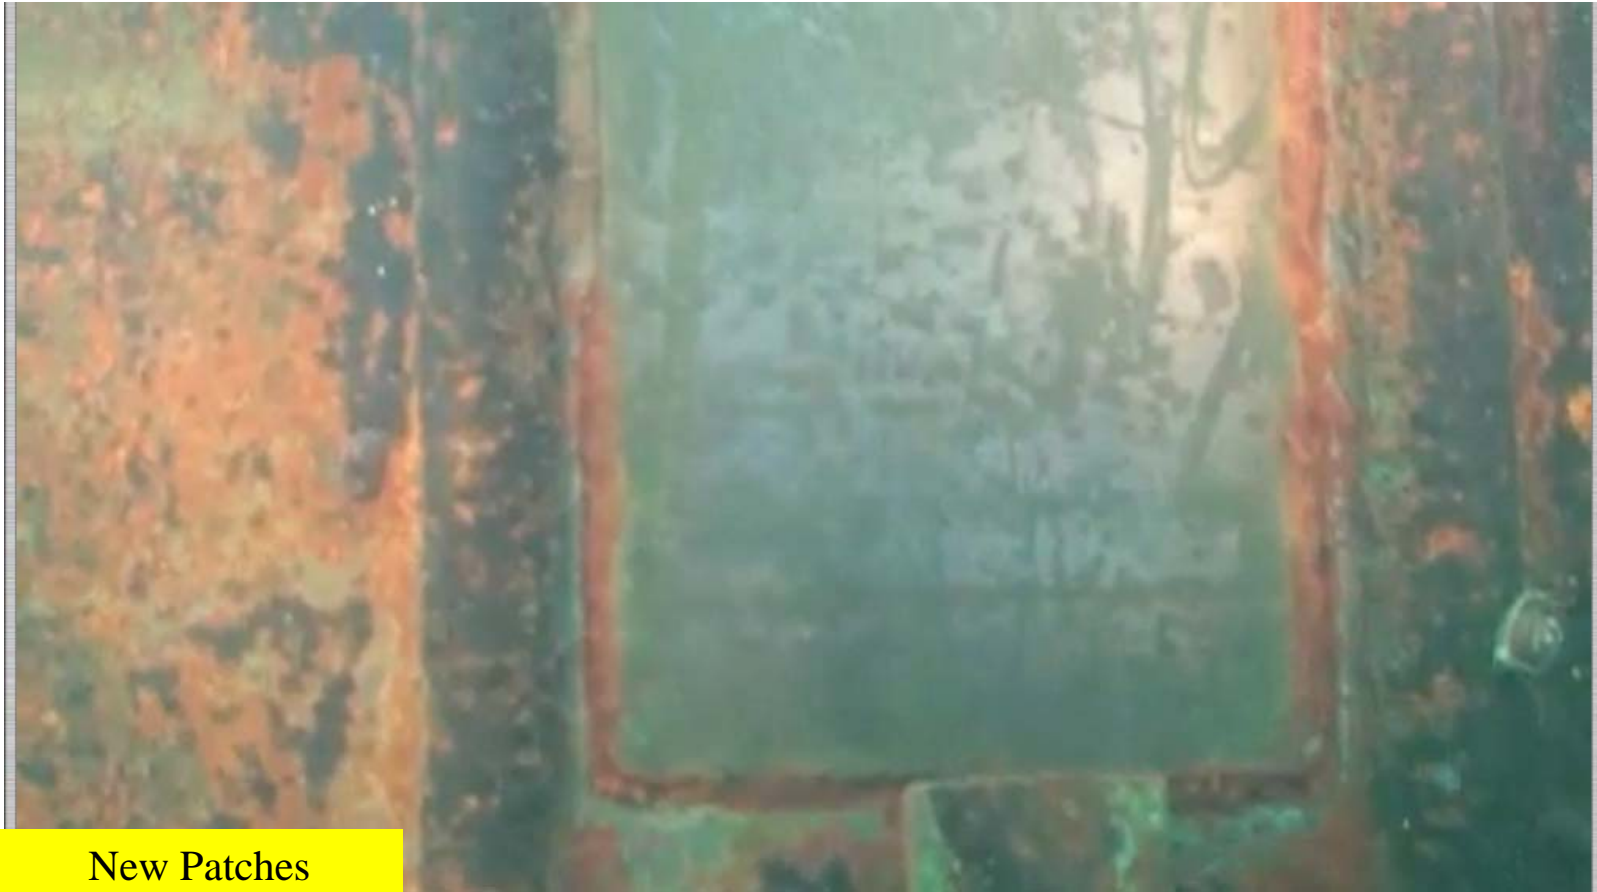
# Hole Repair

New Patches  
beginning to corrode

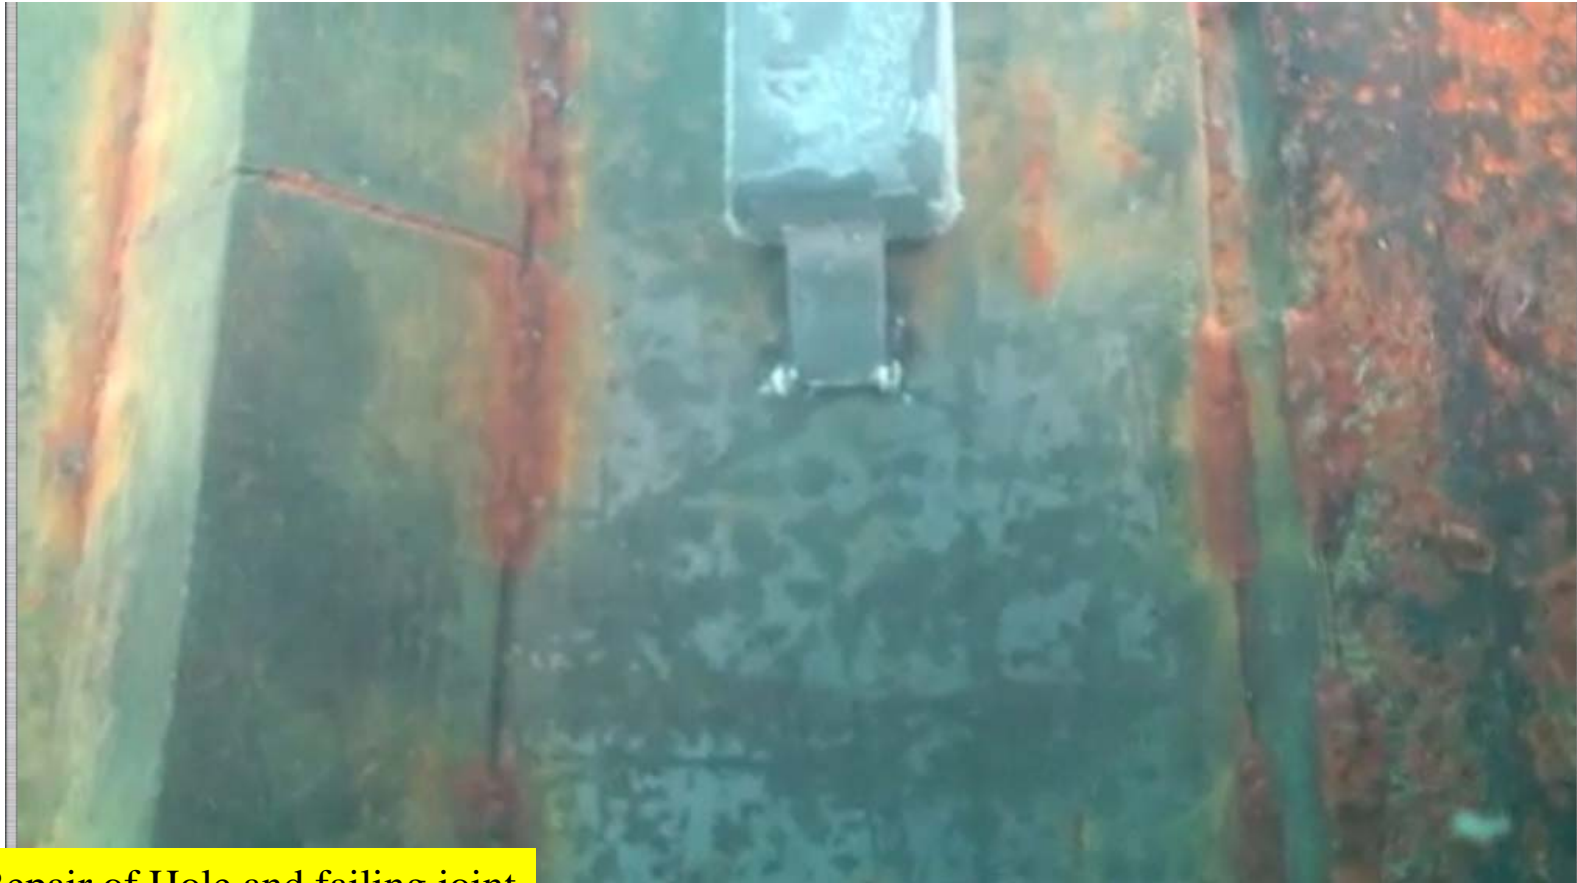
# Hole and Joint Repair

Repair of Hole and failing joint
